REPORT ON TREES IN RELATION TO A PROPOSED DEVELOPMENT ON LAND NORTH OF BAY VIEW TERRACE, DINAS CROSS, NEWPORT, PEMBROKESHIRE

# **Prepared by:** Paul Cleaver Cert Arb L6 (ABC), MArborA, CUEW, RCArborA, MICFor Chartered Arboriculturist

Date: 24<sup>th</sup> March 2022

PC21-220

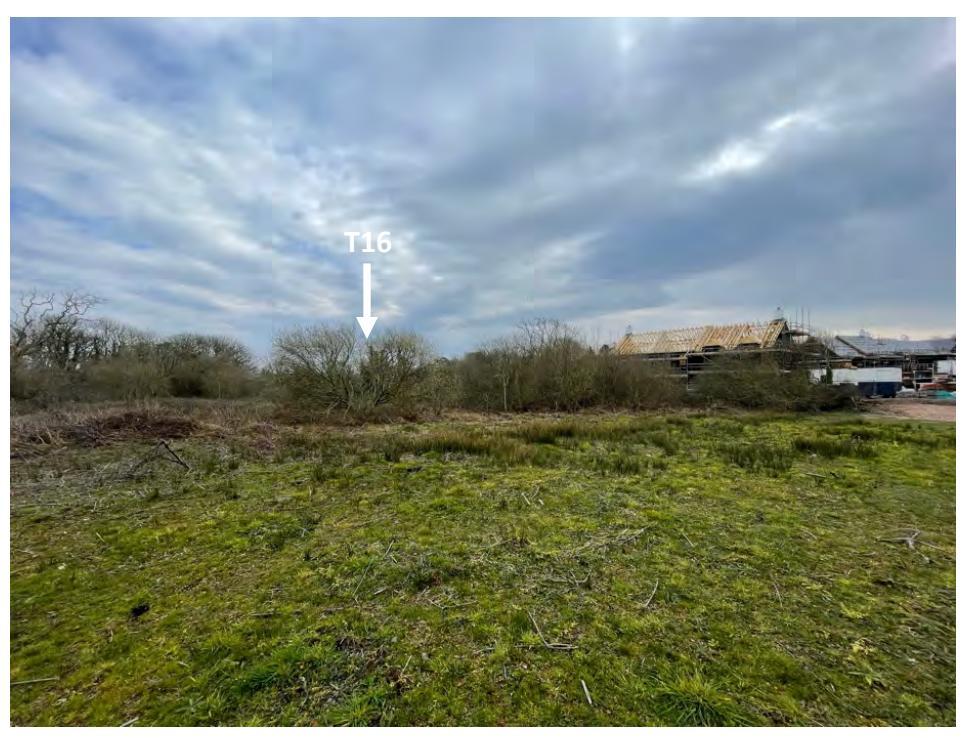
Figure 2: Site and T16, looking southeast with Phase 1 site in the background

H15	Holly Ash Sycamore Hawthorn	8	200 [1]	Mature	2.5	2.5	2.5	2.5	No	В	Management plan needed to conserve hedge and prevent future nuisance issues.
T16	Willow	5	200 [5]	Mature	4	4	4	4	No	U	Collapsing stems. <u>Remove tree.</u>

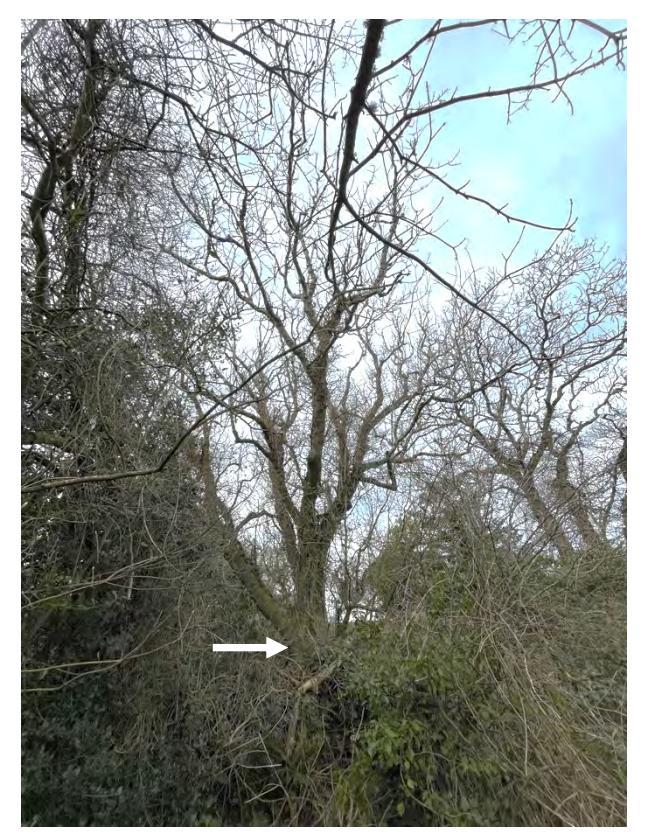
Figure 6: T1, looking north

Tree No.	Species	Height (m)	Stem dia.	Maturity	(	Crown spread (m)		Low branches	Cat	Notes & Work recommendations	
		(,	(mm)		Ν	E	S	w			
T1	Ash	14	1000 [1]	Mature	6.5	6	5	5	No	C3	Low vigour, canker and epicormic growth, symptomatic of Ash dieback disease (ADD). Category reduced due to likely mortality within 10 years.
T2	Ash	14	600 [2]	Mature	6	8.5	5	5	No	C3	ADD low vigour, epicormic growth. Category reduced due to likely mortality within 10 years.
Т3	Willow	7	150 [4]	Mature	0	4	2	0	No	U	Tree propped against neighbouring sycamore.
G4	Ash Sycamore	9	200 100 [2]	Maturing	2	3	4	2	No	C1	-
T5	Ash	9	200 [1]	Maturing	1	2.5	3	3	No	C1	Canker and ADD symptoms.
Т6	Sycamore	9	200 [2]	Maturing	4	4	3	3	No	C1	-
Τ7	Sycamore	14	300 [2]	Mature	5.5	6.5	6.5	5	No	U	Poor form, tight union and pressed stems at base.
Т8	Alder	10	300 [1]	Maturing	3.5	3.5	3.5	3.5	No	В	-
Н9	Blackthorn Sycamore Holly Willow	10	200 [1]	Mature	2	2	2	2	No	В	Oldest trees (thorns) in poor condition. <u>Management plan needed to</u> <u>conserve hedge and prevent</u> <u>future nuisance issues.</u>

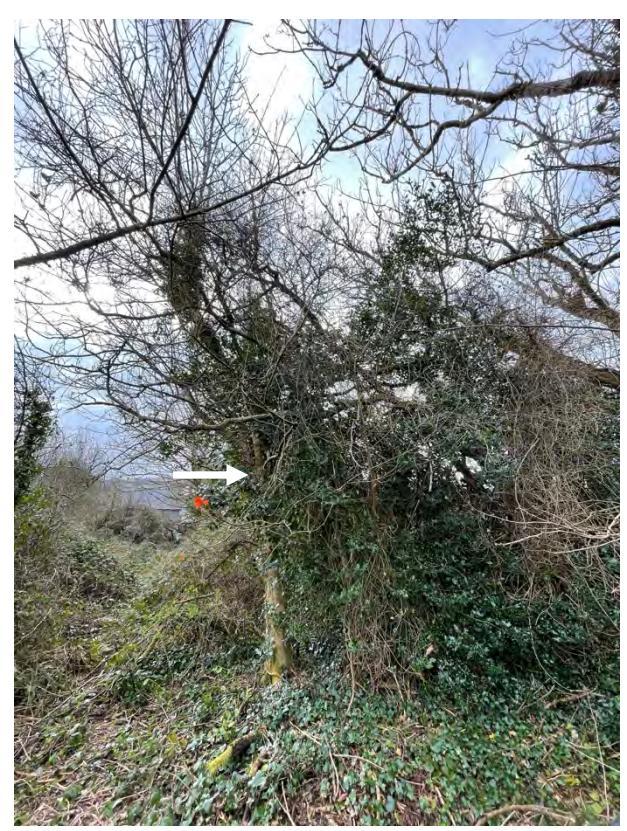
Figure 8: T3 & G4, looking south

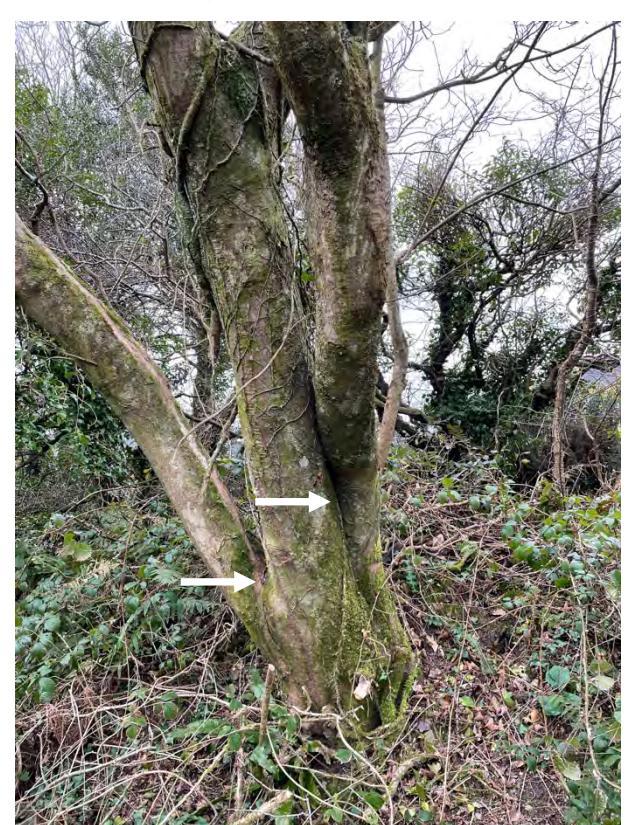
Figure 10: T7, poor form

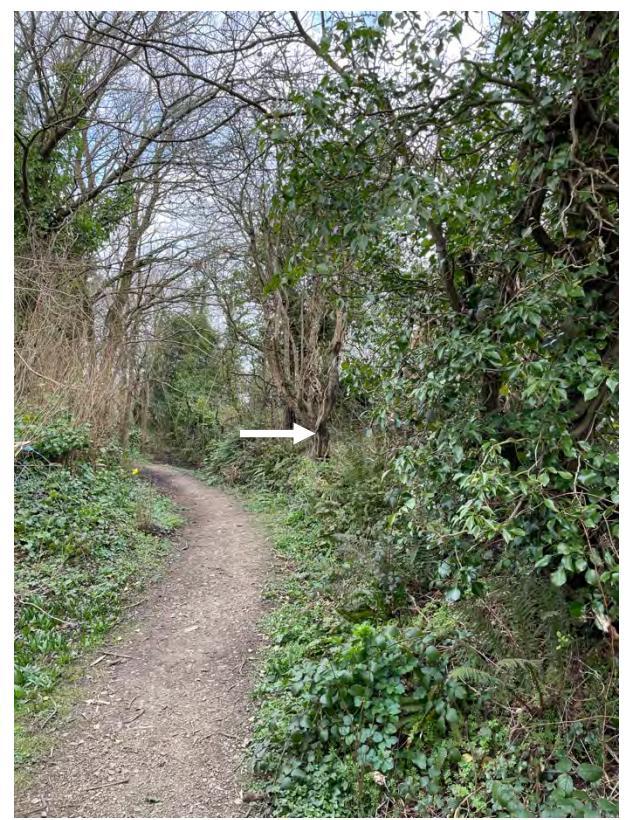
Figure 11: H9, looking north from public right of way

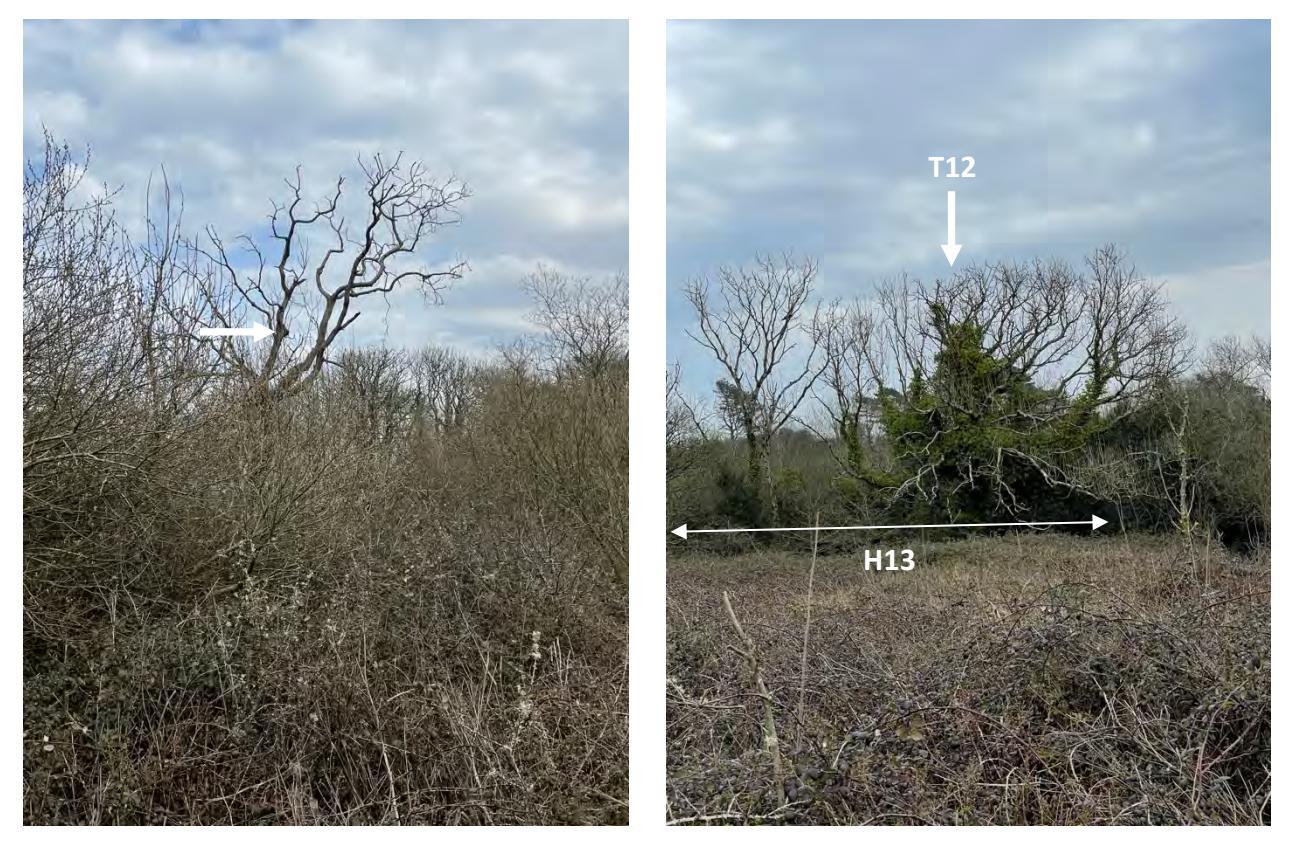
Figure 12: T10, looking northeast

Tree	Species	Height (m)	Stem dia.	Maturity		Crown (r	spreac n)	ł	Low	Cat	Notes & Work recommendations
100.		(111)	(mm)		N	E	S	w	branches		work recommendations
T10	Ash	12	800 [1]	Mature	5	5	5	5	No	U	Major crown dieback, no realistic prospect for recovery. <u>Remove tree, leaving stem as a</u> <u>4.5m tall monolith.</u>
H11	Hawthorn Ash Holly	7	200 [1]	Mature	3	3	3	3	No	В	
T12	Ash	14	950 [1]	Mature	7	7	7	7	No	U	Significant crown dieback, poor vitality and epicormic growth, symptomatic of ADD. Ivy clad. <u>Remove tree, leaving stem as a</u> <u>4.5m tall monolith.</u>
H13	Sycamore Hawthorn Ash Holly Willow	8	200 [1]	Mature	3	3	3	3	No	В	Management plan needed to conserve hedge and prevent future nuisance issues.
T14	Ash	14	800 [1]	Mature	5	7	7	5	No	C3	Tree retained on the Phase 1 site. Hedgebank and stream potentially influencing root spread into Phase 2 site. Sparse crown, apical dieback and epicormic growth, symptomatic of ADD.

Trees that will be affected									
		British Standard	5837 category								
	А	В	С	U							
	(High quality)	(Moderate quality)	(Low quality)	(Poor condition)							
Trees to be removed	-	-	-	T10, T12 & T16							
Trees to be pruned	-	-	-	-

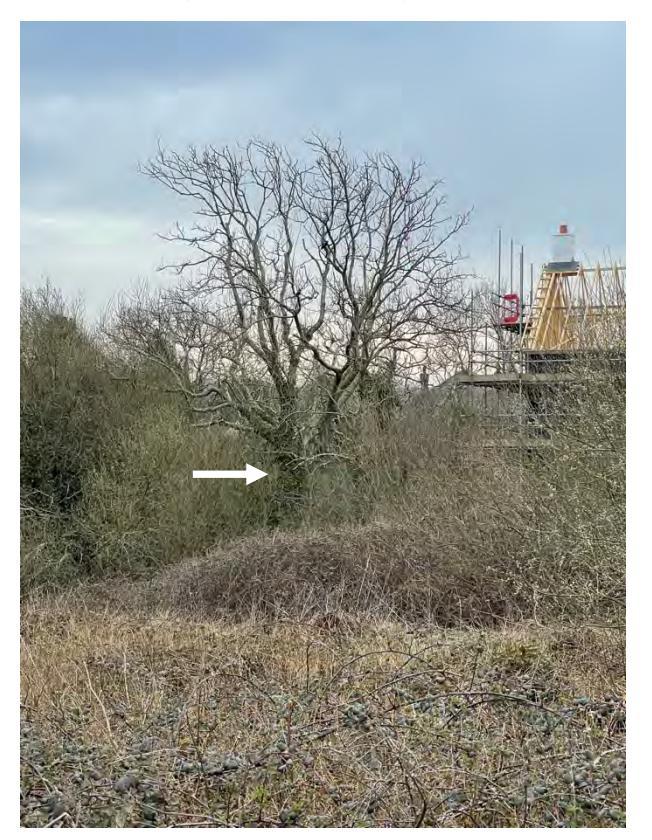
Figure 14: T14, looking south
