Bat Surveys

**The Barn, North Bay View Terrace,
Dinas Cross, Pembrokeshire**

Final Report

July 2021

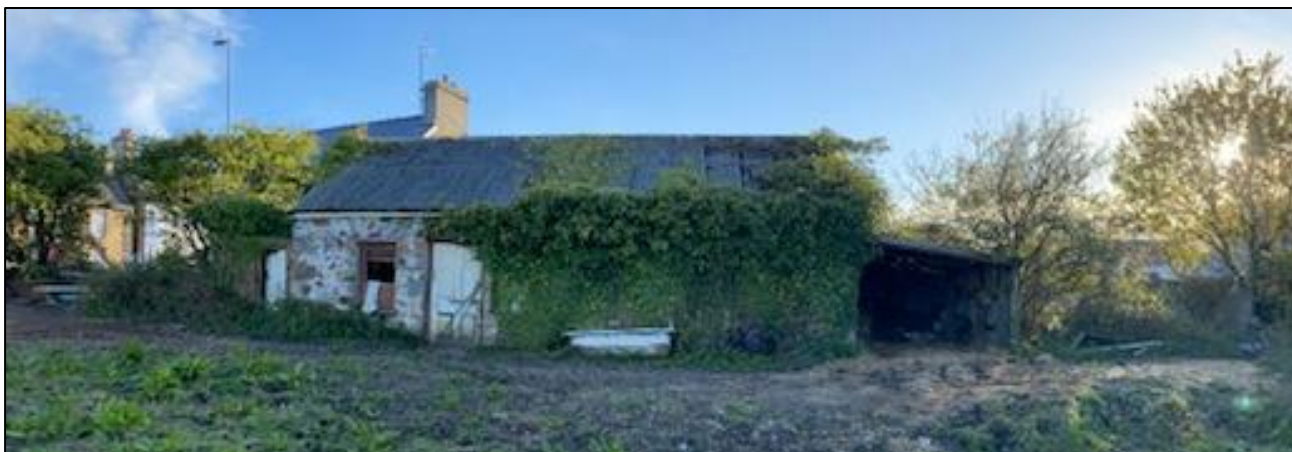
- 2.2 The survey relates to a single storey stone walled barn that has an unlined corrugated cement fibre roof. The gable ends are well bedded down with no gaps externally and cobwebs along them internally. Internally, the barn has been used as a stable with the floor covered in straw as well as a number of stored items. There are single storey lean to extensions on either gable end. The northern lean to has corrugated cement fibre walls and roof, while the southern lean to has brick walls, with a partially collapsed roof. The window on the northern gable end of the main barn has broken, so there is fly in access to the building.

Figure 1. Eastern aspect of the barn.

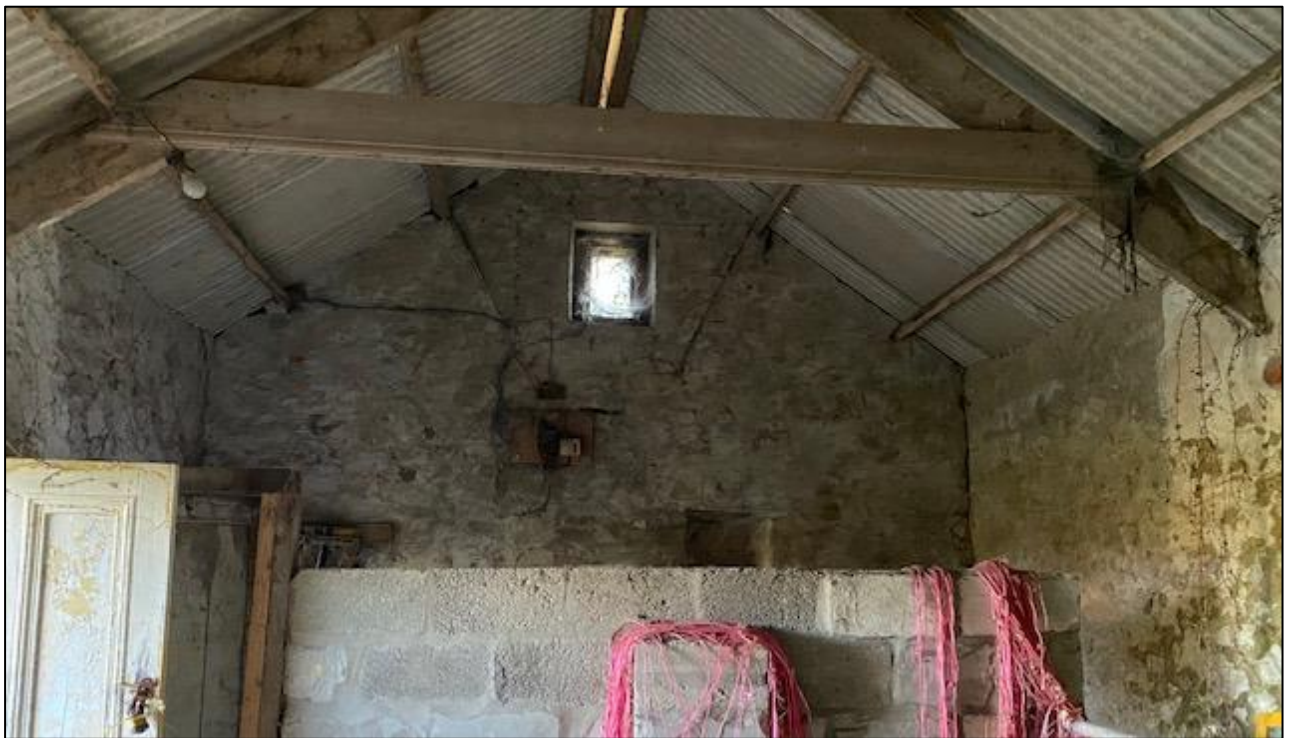
No evidence of bats was found either internally or externally. All roof coverings are intact and as there are windows on the northern, southern and western elevation, there was an internal LUX reading of 35. A summary of LUX levels is described in Table 2, with the level recorded inside the barn highlighted in red. The gable end walls are very well bedded down with no gaps externally and cobwebs along them internally (Figure 3). The window on the northern gable end of the main barn has broken, so there is fly in access to the building (Figure 4). All sections of the building were accessible and had not been cleaned prior to the survey being completed.

Figure 3. Internal view of the southern gable end of the barn.

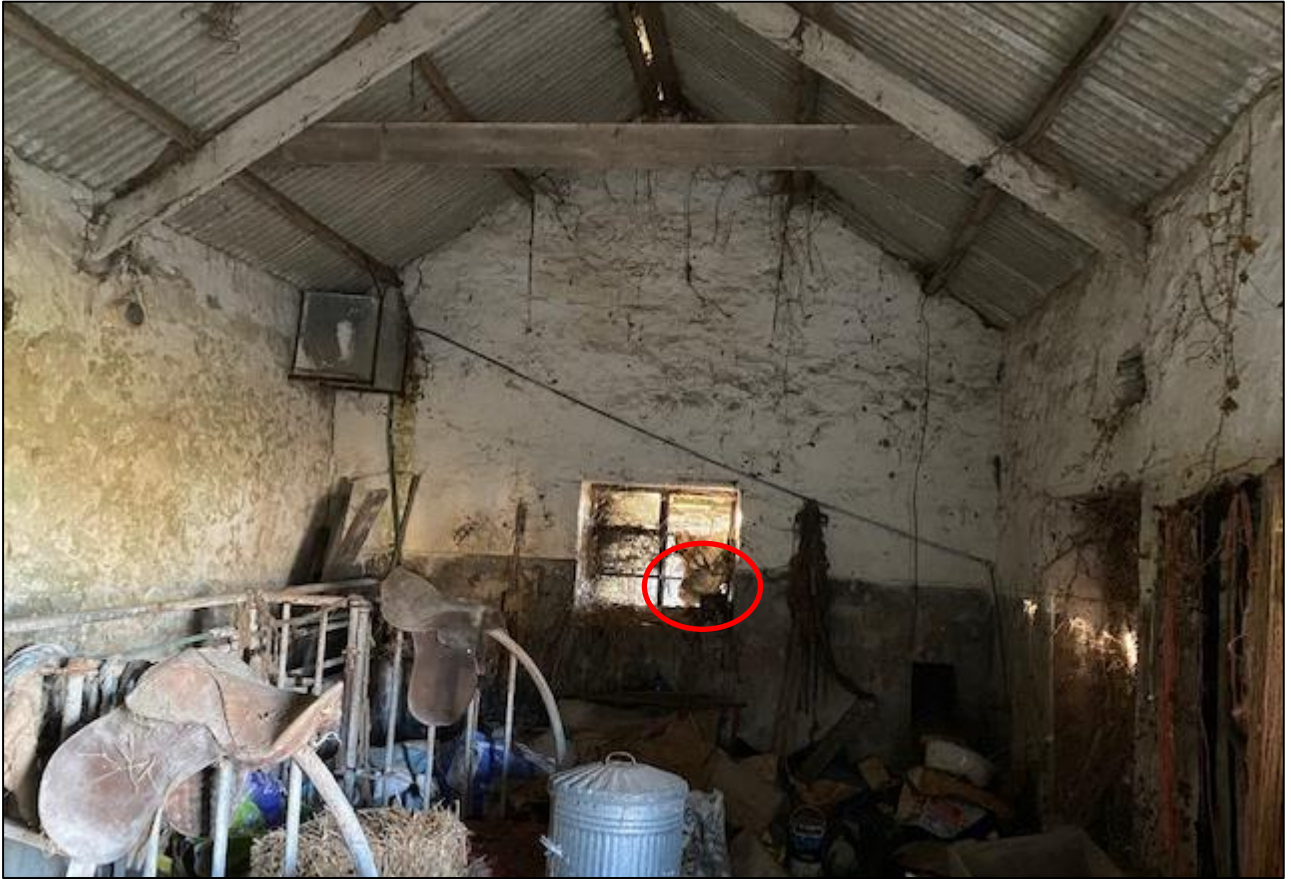
Figure 4. Internal view of the barn with the broken window on the northern gable end highlighted.

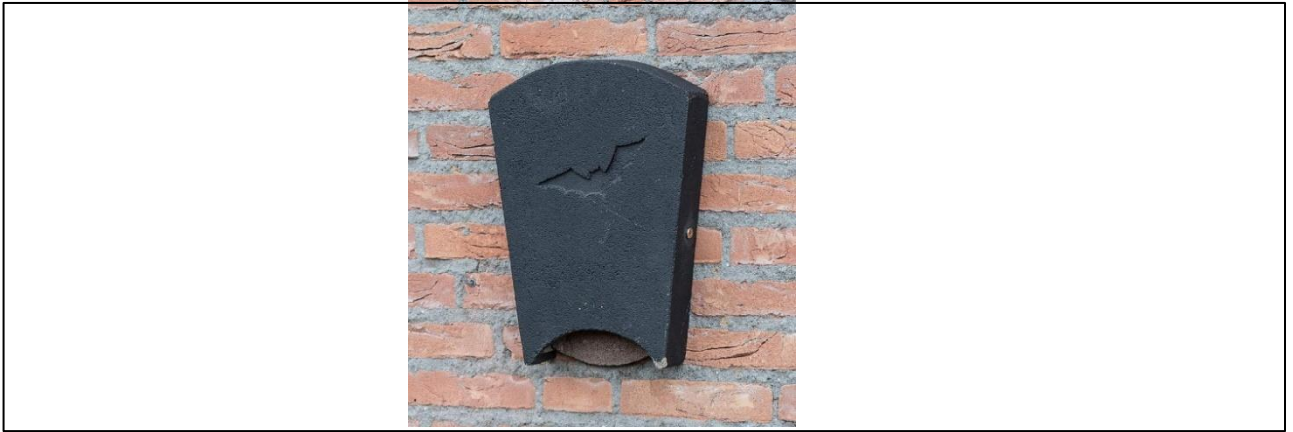
Figure 5. Example of a Beaumaris woodstone bat box.

To enhance the roosting opportunities on site, a bat box will be included in the scheme. In this instance, a Beaumaris woodstone bat box or similar design would be most appropriate as these are flat backed to fit against buildings. Bat boxes should be sited as high up on a building as possible but, avoid being positioned over windows or doors. An example is shown in Figure 5.

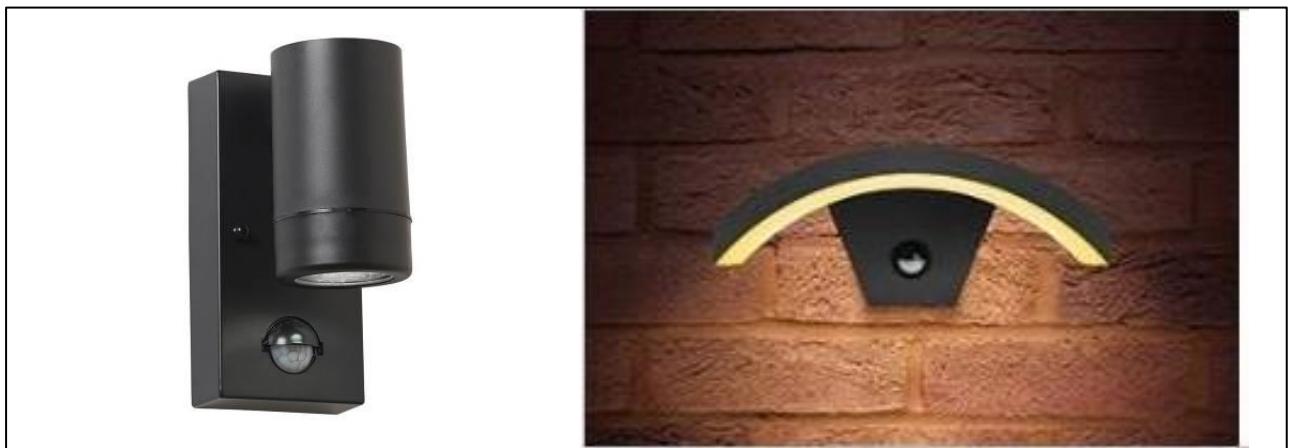
Figure 6. Example of different PIR LED lighting.

As bats are in the area, any new external lighting should be hooded, downward facing and positioned to avoid shining directly onto the features such as woodland edges and hedgerows. The lighting should also be PIR sensitive LED type which have a much more directional lighting range. An example is shown in Figure 6.
